Intermittent Loss of Power on Volkswagen Turbo Diesel

**Oleg Malin, Vasyl Postolovskyi
& Olle Gladso**

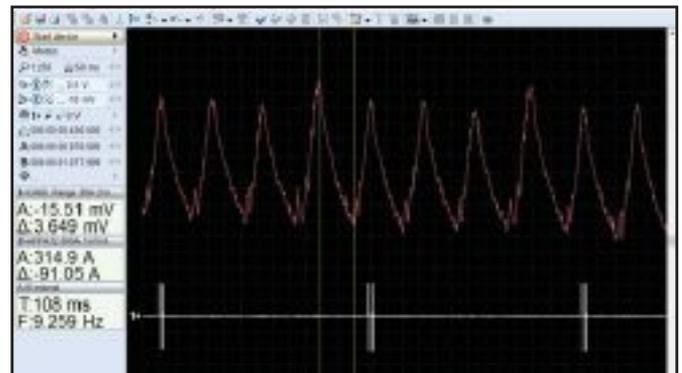
Figure 1: Cranking current waveform.

Figure 1 shows the cranking waveform obtained using the setup described.

The relative compression waveform did not reveal anything out of the ordinary. The delta current or compression peak current was about 90 A. Cylinder number 2 had a slightly higher delta than the others, all the rest were about the same. But what was the cause of exhaust being blown back out of the intake?

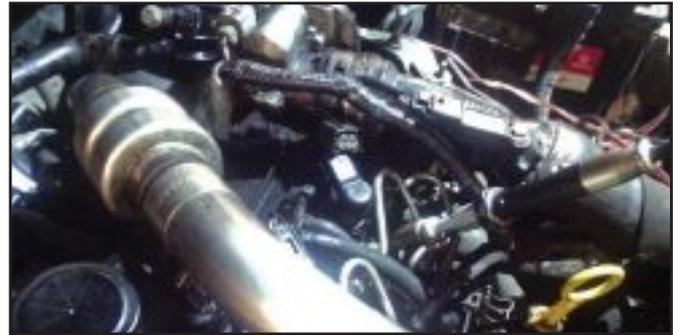
Since it is fairly easy to get to the glow plugs on this particular engine, it was decided to check absolute compression. The px35 pressure sensor from the Autoscope kit was used for this task as shown in **Figure 2** on page 12.

- Cylinder number 1: 21.7 Bar (319 psi).
- Cylinder number 2: 22.8 Bar (335 psi).
- Cylinder number 3: 21.8 Bar (320 psi).
- Cylinder number 4: 21.5 Bar (316 psi).

When taking into account the added volume from the extension used with the pressure transducer, the compression readings were normal, with cylinder number 2 being slightly higher. This was the same result as what was obtained using the relative compression test earlier.

Figure 2: The pressure transducer attached in place of a glow plug.

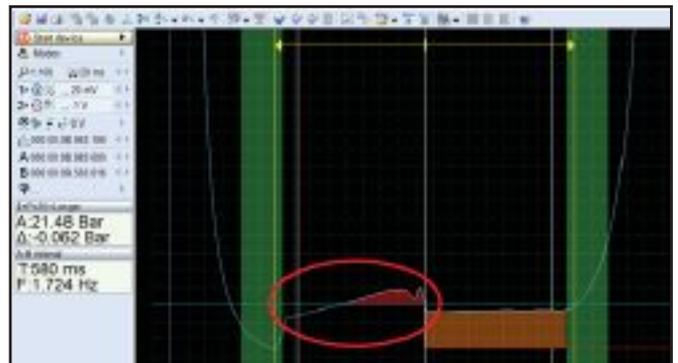
Since the Autoscope was used along with the pressure transducer, we now had cylinder pressure waveforms. Cylinder pressure waveforms can reveal much more information than just cylinder pressures. **Figure 3** shows the cylinder pressure waveform taken from one of the cylinders.

The circled area in **Figure 3** shows an incline, which indicates an increase in cylinder pressure on the cylinder's exhaust stroke. This is not normally observed on a diesel engine. That area of the waveform should be flat or horizontal.

Figure 3: Cylinder pressure waveform.

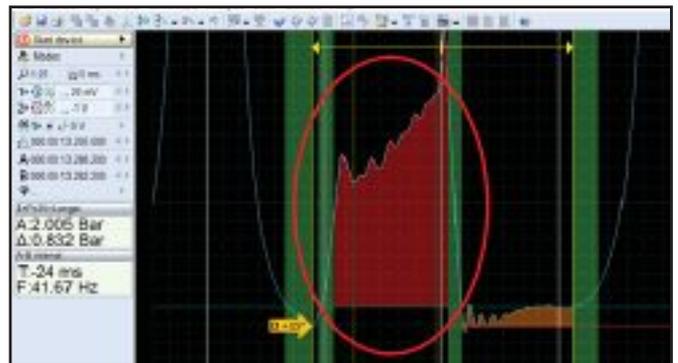
To test further, the pressure transducer was left in the fourth cylinder, the other three injectors were reconnected, the engine was started and allowed to idle. The cylinder pressure waveform was then recorded. **Figure 4** shows the resulting waveform.

The waveform shows that on the exhaust stroke there was a back pressure of about 2 Bars (29 psi)! This was at idle, so there was clearly a complete or almost complete blockage in the exhaust.

Figure 4: Cylinder pressure waveform at idle.

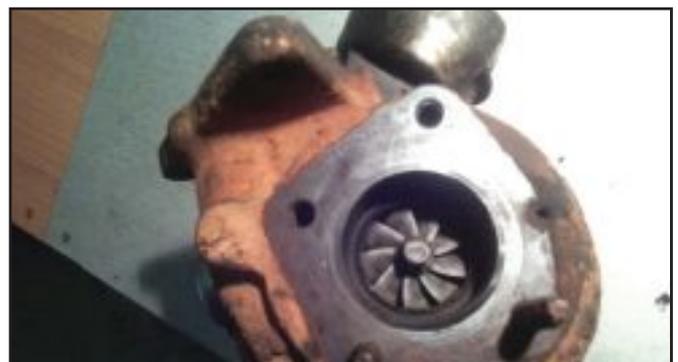
The turbo was removed and inspected. The turbine/compressor assembly was found to be completely seized, causing a severe exhaust blockage. The seized turbo is shown in **Figure 5**.

Since there is usually an underlying reason for this type of failure, the rest of the exhaust system was inspected and found to be partially plugged. The partial restriction caused excessive exhaust temperatures which, in turn, caused the turbo failure. The exhaust system was repaired and the turbo replaced. If the exhaust system had been left alone, the likely result would have been another turbo failure. **TS**

Figure 5: The seized turbo.
